## Void Filling at Welspun Factory, Vapi - 20/2/09

## Methodology

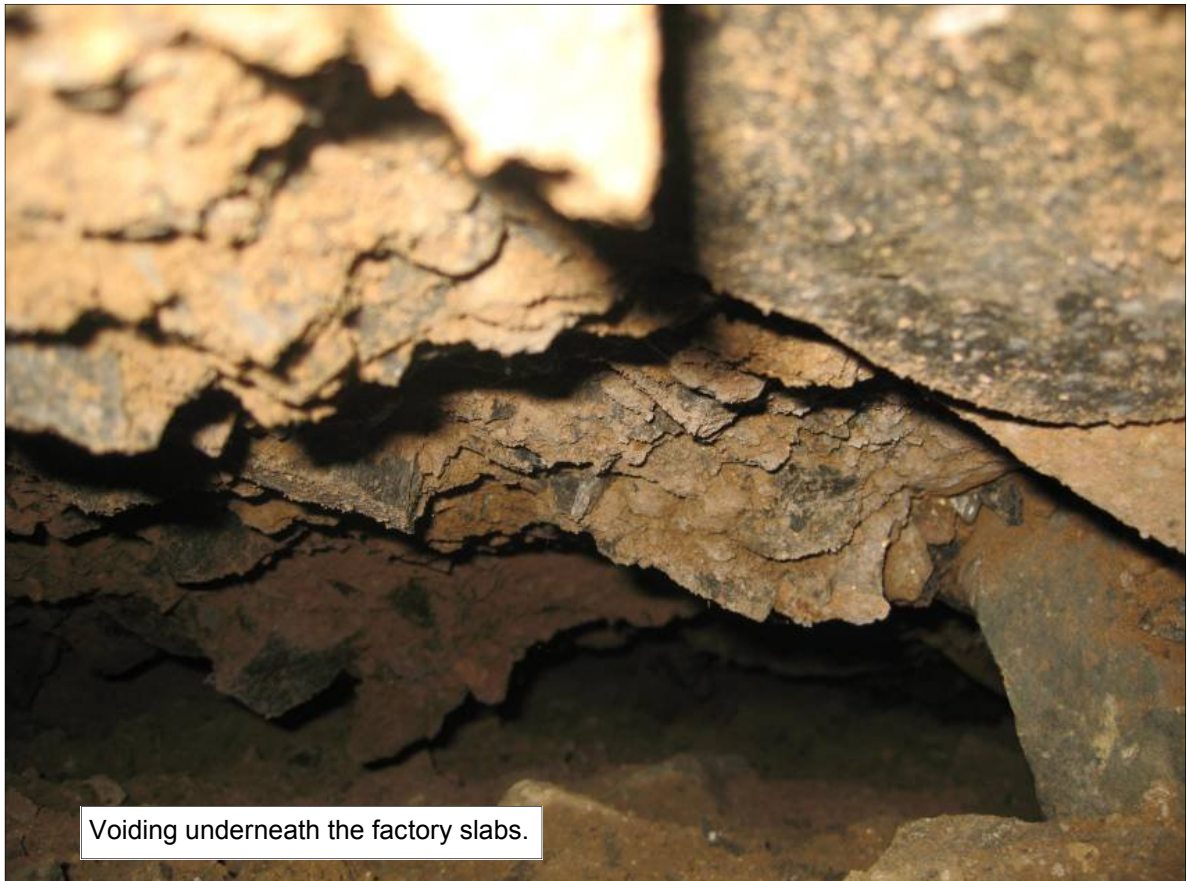
Voiding underneath the factory slabs.

- Confirm presence of voiding - also confirmed by photographs whilst onsite (see below).
- Underseal slabs and fill voids in area of trial
- Deep Inject under the sub-base to compact the soils to prevent further subsidence of slabs in that location
- Raise sunken slabs and re-level with respect to adjacent slabs

The holes were drilled using 16mm x 900mm and 16mm x 1500mm bits. Distinct voids could be felt between the slab and the base slab (approx 50mm void) and then as the drilling continued through the bottom of the base slab voiding was present underneath. The soil underneath the base slab was surprisingly soft and easy to drill.

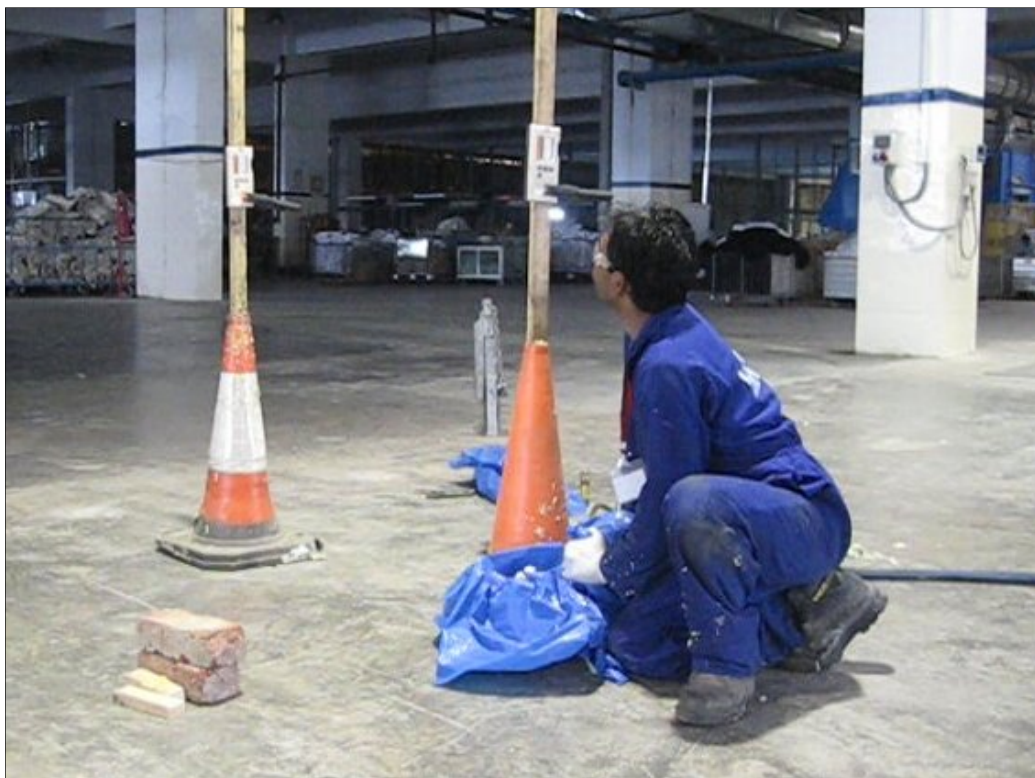
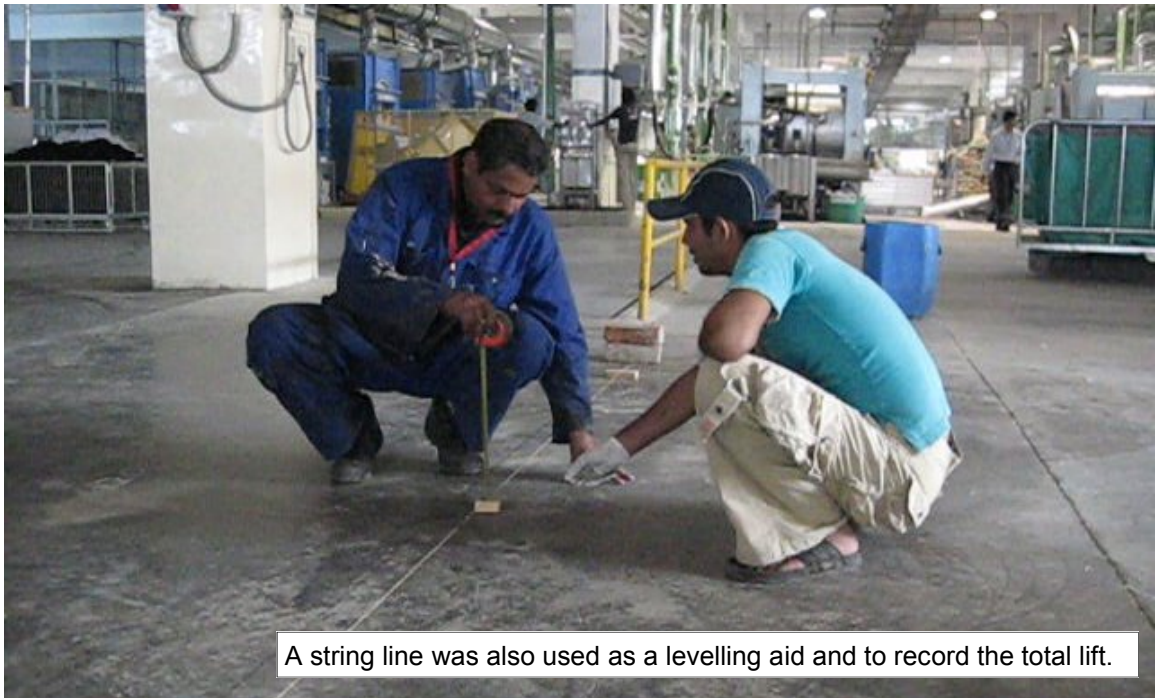
This was done by using a fine beam rotating laser placed on a remote slab with finely calibrated receivers mounted on staffs placed on the slab being injected and also the next adjoining slab. The receivers have digital read out in millimetres and are capable of detecting movement in parts of a mm.

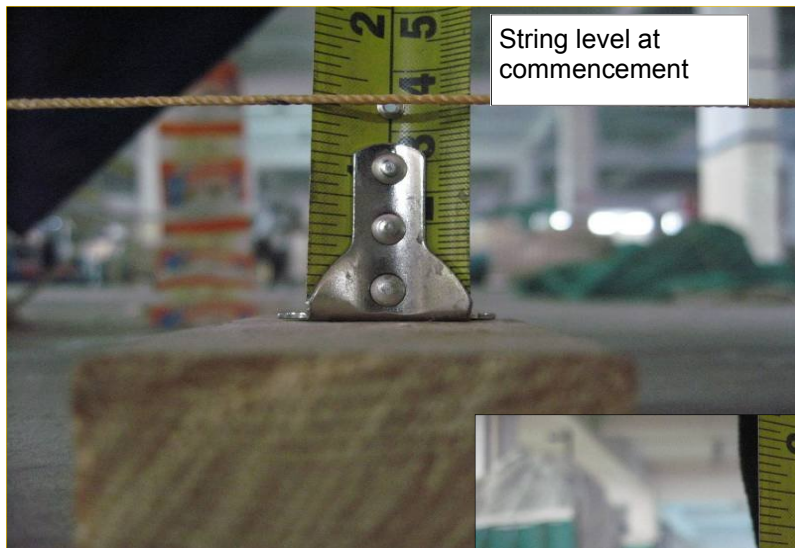
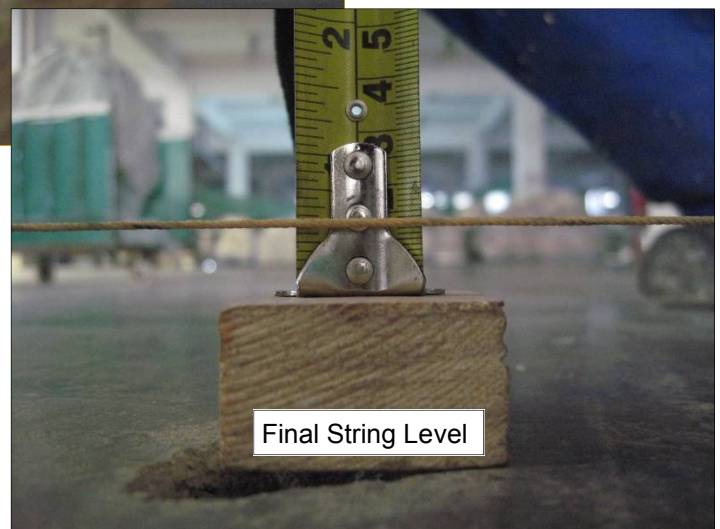
## Graphs Showing the Lift Achieved by Uretek Along 3 Different String Lines at the Welspun Factory, Vapi.

440 kgs. of mixed resin was used. Of this material approximately 150 kgs was used to lift the slabs, 160 kgs was deep injected to compact soils further down, and approximately 130 kgs was used to void fill. Given the size of the problem encountered in this project, these quantities are more conservative than we expected, but they demonstrate ably the capabilities of the very strong Uretek resins.
